INVESTIGATION NO. 2684

THE NASHVILLE, CHATTANOOGA & ST. LOUIS
RAILWAY COMPANY

REPORT IN RE ACCIDENT

MARCH 1, 1943

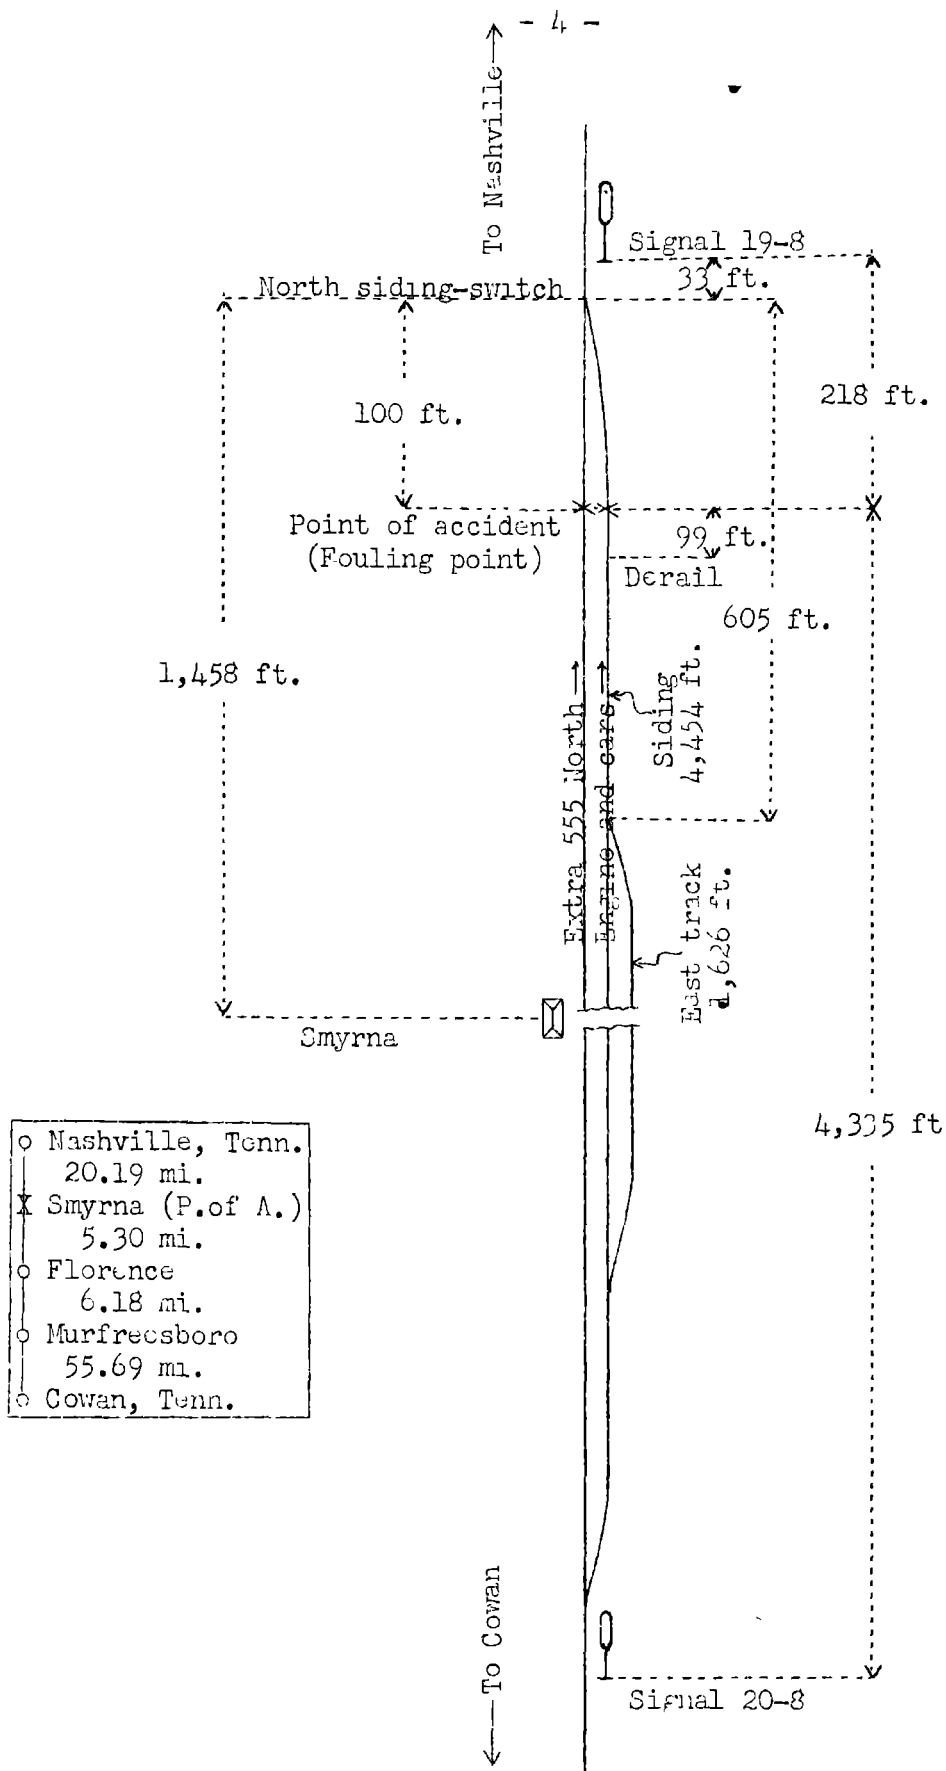
Inv. No. 2684
 Nashville, Chattanooga & St. Louis Railway
 Smyrna, Tenn.
 March 1, 1943

This accident occurred on that part of the Chattanooga Division which extends between Cowan and Nashville, Tenn., 37.36 miles. In the vicinity of the point of accident this is a single-track line over which trains are operated by timetable, train orders and an automatic block-signal system. At Smyrna a siding 4,454 feet in length parallels the main track on the east. The north switch of this siding is 1,458 feet north of the station. The accident occurred at the fouling point of the turnout about 100 feet south of the north siding-switch. Approaching from the south the track is tangent a distance of more than 1 mile to the point of accident. At the point of collision the grade for north-bound trains is 0.9 percent descending.

A derail is located on the east rail of the siding at a point 199 feet south of the switch and 14 feet south of the clearance point. This derail is connected to the north siding-switch and operates in conjunction with it. When the north siding-switch is lined for a main-track movement, the derail is in derailing position. An industry track 1,626 feet in length parallels the siding on the east. The north switch of this track is 605 feet south of the north siding-switch.

Automatic signals 20-8 and 19-8, which govern north-bound movements, are located, respectively, 4,335 feet south and 218 feet north of the point of accident. These signals are of the color-light type and are approach lighted.

No. 20, a north-bound third-class freight train, consisting of engine 612, 10 loaded cars and a caboose, was en route from Cowan to Nashville. It entered the siding at Smyrna and stopped into clear at 4:57 p. m. About 6:34 p. m. engine 612, pulling 12 cars, was moving northward on the siding at a speed of about 2 miles per hour when the engine fouled the main track on the turnout of the north siding-switch and was struck by Extra 555 North.

Engine 612 and the first car overturned to the right and stopped bottoms up and considerably damaged, east of the siding and parallel to it, with the front end of the engine opposite the north siding-switch. The second and third cars were derailed but remained upright and in line with the siding. The front truck of the third car was derailed. Engine 555 and its tender were derailed and stopped upright in line with the main track, with the front end of the engine about 210 feet north of the point of accident. The pilot beam and the right cylinder-head were broken. The first and second cars were slightly damaged.
